# ILLINOIS AND MICHIGAN CANAL NATIONAL HERITAGE CORRIDOR

**Volume II: Morris**

HABS/HAER Division  
National Park Service  
U.S. Department of the Interior

### **VOLUME II: MORRIS**

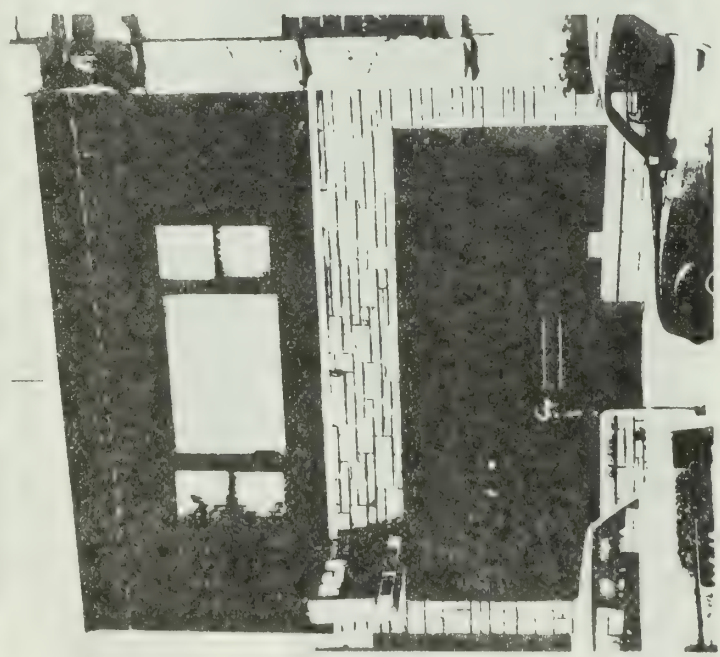
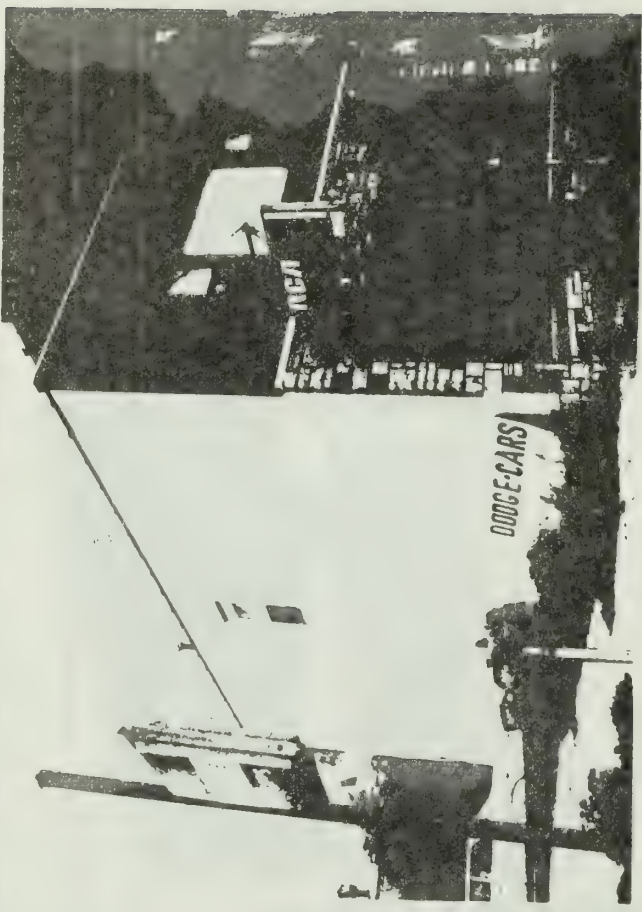
Roll 28, 19

Site is significant for its location across from courthouse, south of the L.W. Claypool building, and one block from the canal. No historical significance; visual intrusion in area of historic structures.

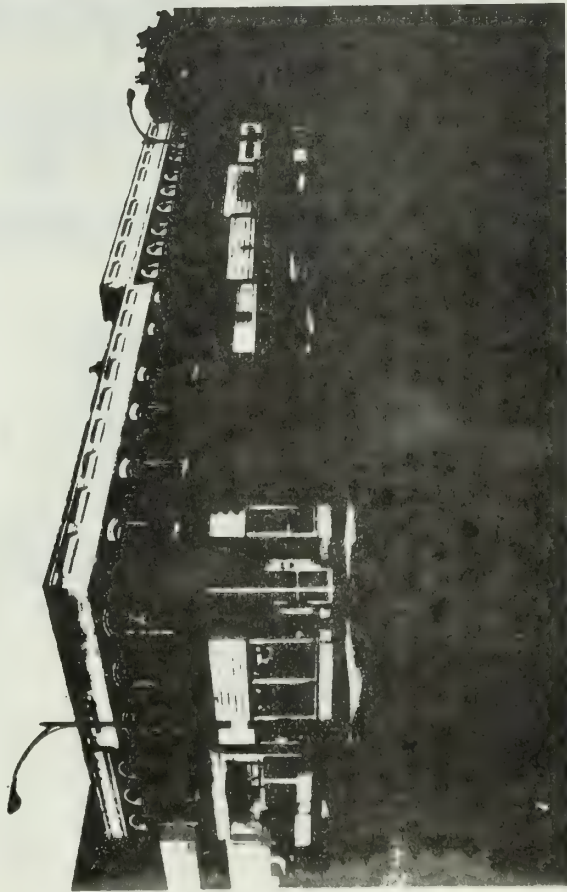
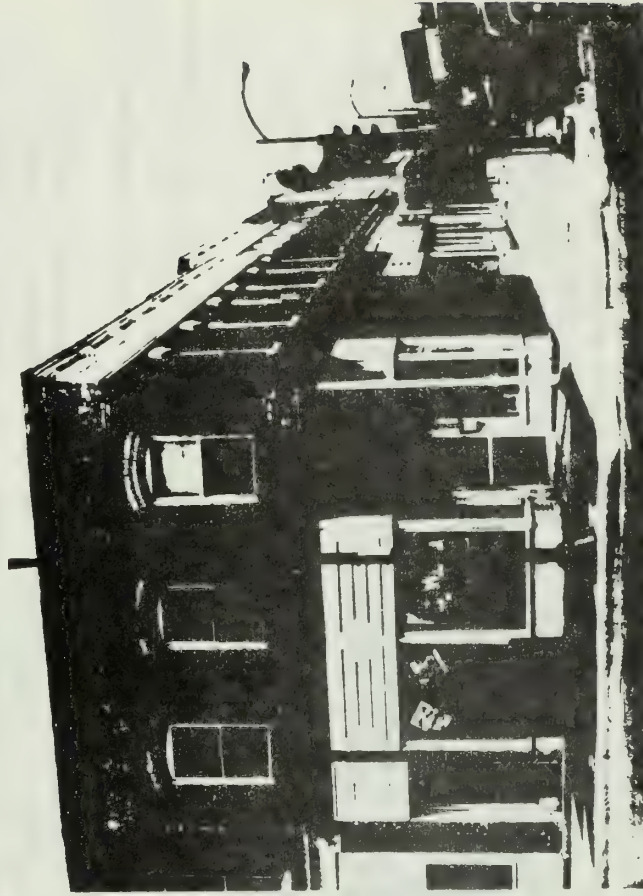
Roll 37, 19

One of early remaining commercial structures in the central business district. Occupies a prominent location at the intersection of the two principal commercial streets in Morris. Significant in the development of Morris as the commercial center for Grundy County after the opening of the I&M Canal. Adjacent buildings to the north and west are part of a complex known as the Porter-Pike-Hoffman Building. Structure retains a substantial amount of integrity.

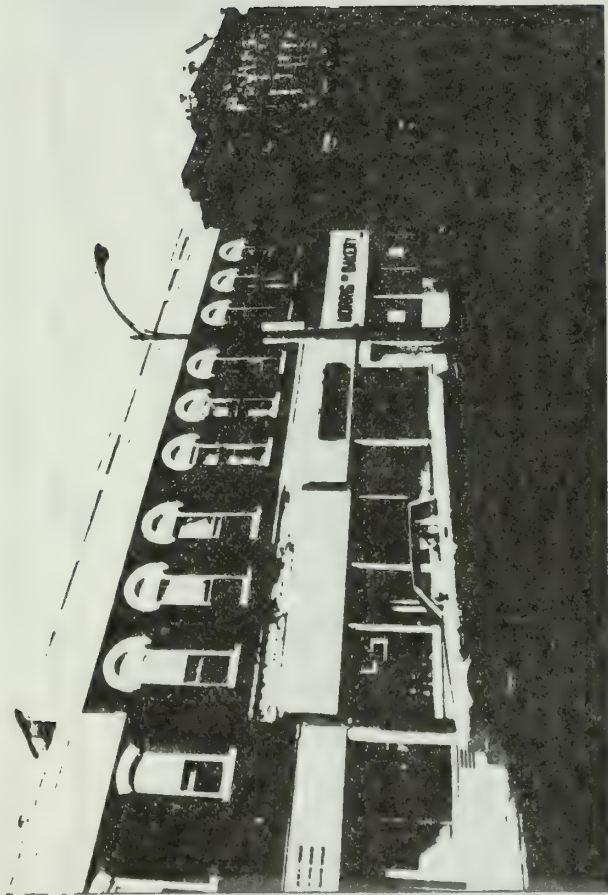
Roll 37, 18

Part of major commercial block at intersection of principal commercial streets in Morris central business district. One of the early commercial structures remaining in Morris that still retains a significant amount of integrity. Important in the development of Morris as the commercial center for Grundy County.

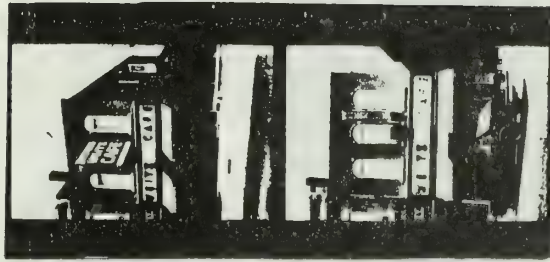
Roll 32

An early restaurant (M.N. Hull, 1877), the building illustrates the scale and variety of commercial activity generated by the I&M Canal in the 1800s. Alterations have compromised the architectural integrity of the structure.

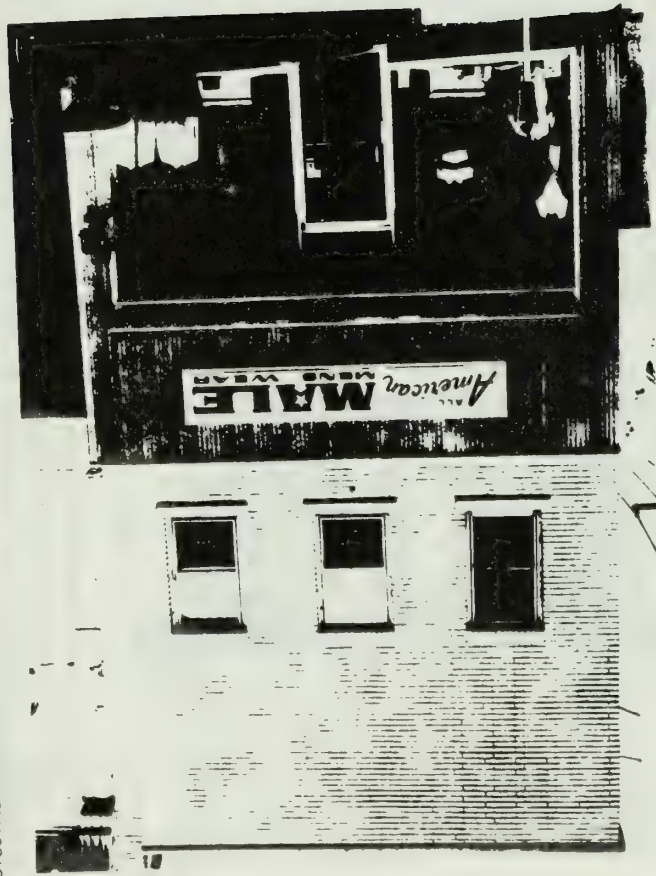
Roll 28, 0

Located on the principal commercial street in the central business district, the structure illustrates the scale of commercial structures built along Liberty Street during the early years of Morris' development. The stucco cladding treatment and storefront modifications have destroyed much of the architectural integrity of the building.

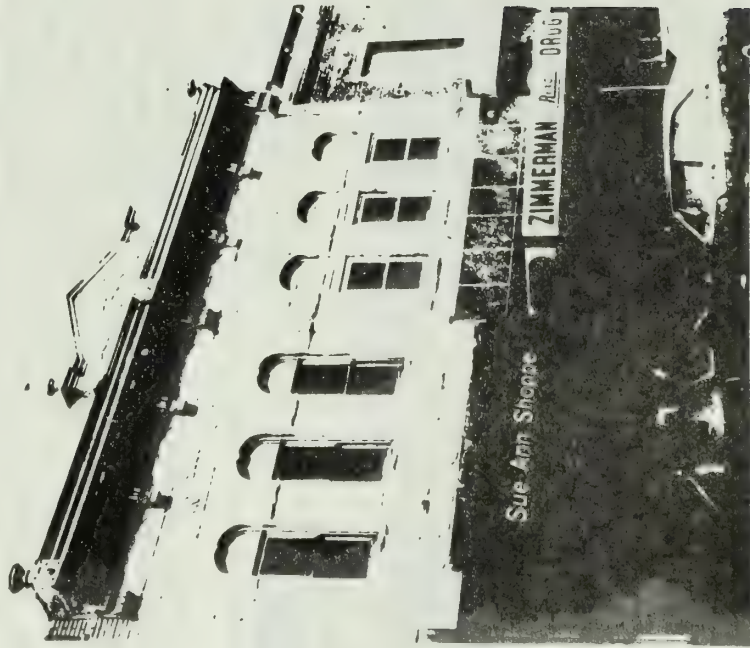
Roll 28, 1

Built during a time of rapid growth of Morris commercial activity northward on Liberty St., the building is important in the development of Morris as the commercial center for Grundy County. Noble Robinson was a prominent Morris resident, born in England in 1840. He came to the U.S. at the age of eleven and having worked as a coal miner, came to Morris in 1872 and went into the liquor business with William Allen with whom he opened a saloon and billiard parlor in this building in 1877. H.H. Holtzman was born in Washington, D.C. in 1837 and came to Morris in 1855. Building is one of three large sandstone Italianate commercial structures in Morris, all with severe stone deterioration. Building was sandblasted during the summer of 1985 and much of the detail, pictured in the photograph below has been removed.

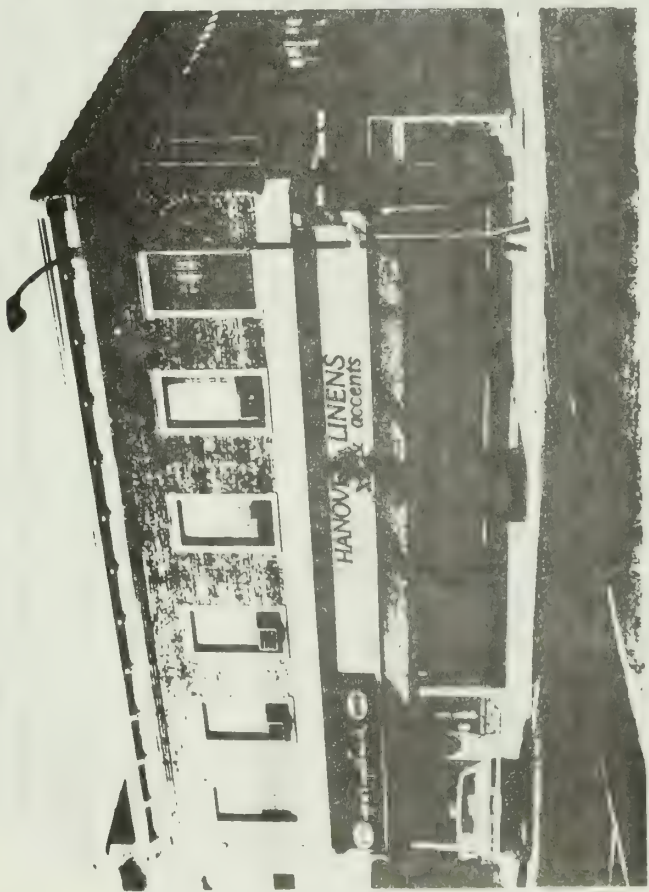
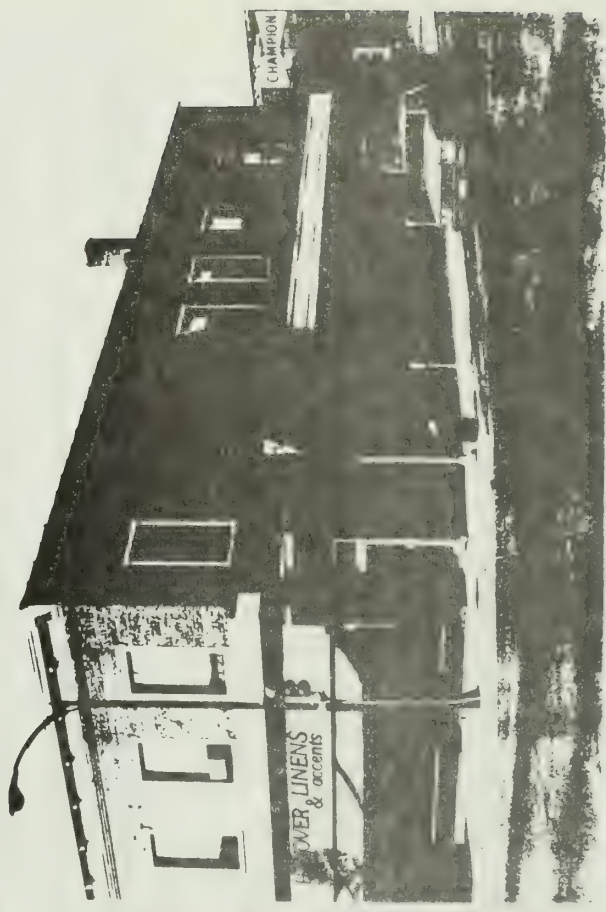
Roll 28, 2

Common bond red brick walls. Rectangular plan; six-bay main facade. Two stories. Flat roof with parapet wall, terracotta coping on north; metal cornice with modillions and horizontal panels, corner fluted brackets on main facade; north wall has brick corbelling and end wall replacement chimney. Two modern replacement storefronts with metal signboards, modern glass display windows; wood fascia board above signage extended from wall with metal braces. Second story has six replacement fixed one-light metal frame windows with wooden surrounds, fluted stile, flat lintels with articulated keystones. Main facade faces east; corner location on principal commercial street. Alterations include added, enclosed entrance to second-story offices on east end of north facade. Earlier brick buildings on site housed dry goods, boots and shoes, and druggist. This building was constructed for T.H. Hall; purchased by C.H. and John Hynds in 1913 and still owned by the Hynds family.

Example of early 20th century structure indicative of the continued development of Morris as the commercial center for Grundy County. Built by prominent citizen, T. H. Hall, who was born in Morris in 1862. A drygoods merchant, he was married to a daughter of Louis Gebhard, founder of the Gebhard Brewery. Hynds family has also been important in the development of Morris since the early years of settlement.

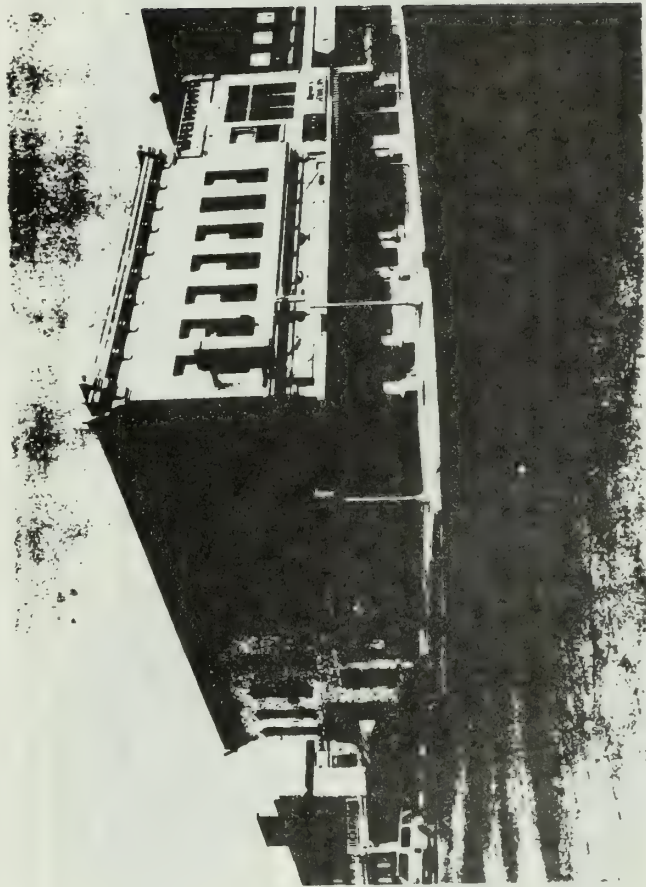
Roll 29, 1

Important in the development of Morris as the commercial and financial center of Grundy County. Architecturally, building has been drastically altered from its nineteenth century appearance, although it does exhibit the changes in taste as applied to buildings in the early part of the twentieth century. Prominent corner location on principal street in central business district. The Gebhard family is significant in the development of Morris as owners of the Gebhard brewery, founded in 1866 by Louis Gebhard and continued by his son William until Prohibition. This structure is one of two Gebhard blocks built during the same decade in this block of Liberty St.

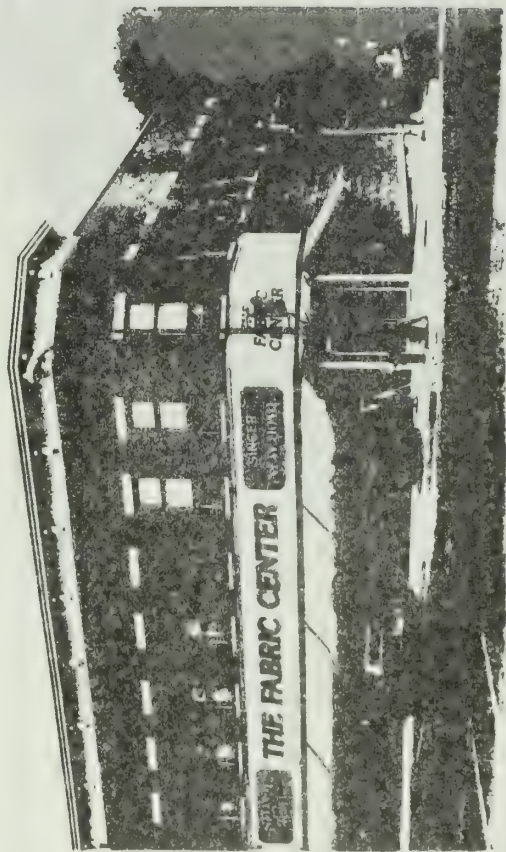
Roll 31, 34

Limestone foundation, limestone water table; red brick walls, running bond on west and common bond on remaining elevations. Square-shaped plan with nine-bay front. Two stories. Flat roof with parapet, cornice with brackets, recessed rectangular panels and decorative floral molding. Two storefronts: central, recessed entrance with metal frame glass door and transom windows, four display windows; canted corner entrance with metal frame glass door with sidelights and three-light transom window, ribbed metal kickplates, wood sign board. Eight second-story double-hung one-over-one-light sash windows with transoms, plain stone lintels and stone lug sills. Main facade faces west; corner location. Alterations include sandblasting and re-pointing, doors and windows have been bricked-up and/or replaced, rear addition ca. 1927. Situated on ruins of the fire of 1888, the building originally housed a furniture and drygoods store. By 1907 a shooting gallery had replaced the furniture store. Historical photographs indicate that the basement of the building was accessible from the street ca. 1910.

Occupying a prominent corner site in the central business district, the building illustrates the northerly progression of Morris' commercial development along Liberty St. from the canal to the railroad in the late 1800s. The building is comparable in size, scale and appearance to other commercial structures of this era.

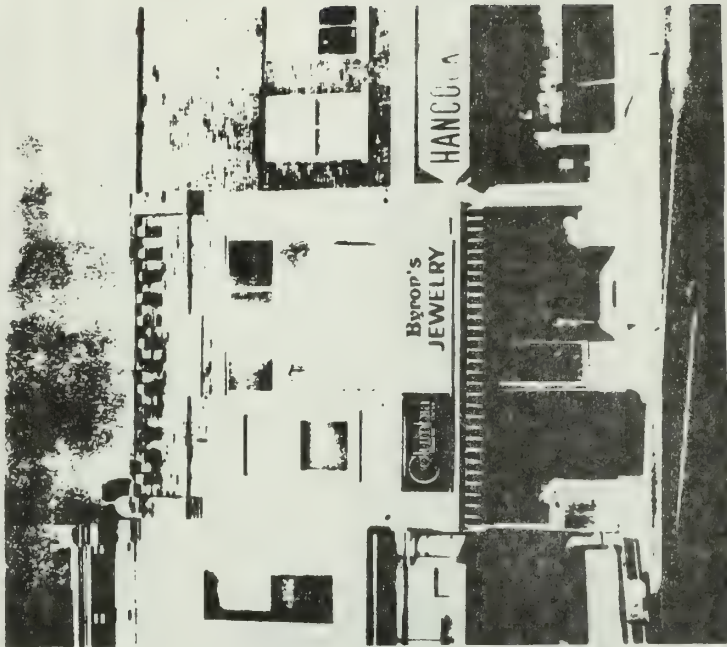
Roll 29, 12

Element in central business district and element in 20th century continued development of Morris as commercial center for Grundy County. Compatible in scale, style and materials with surrounding structures.

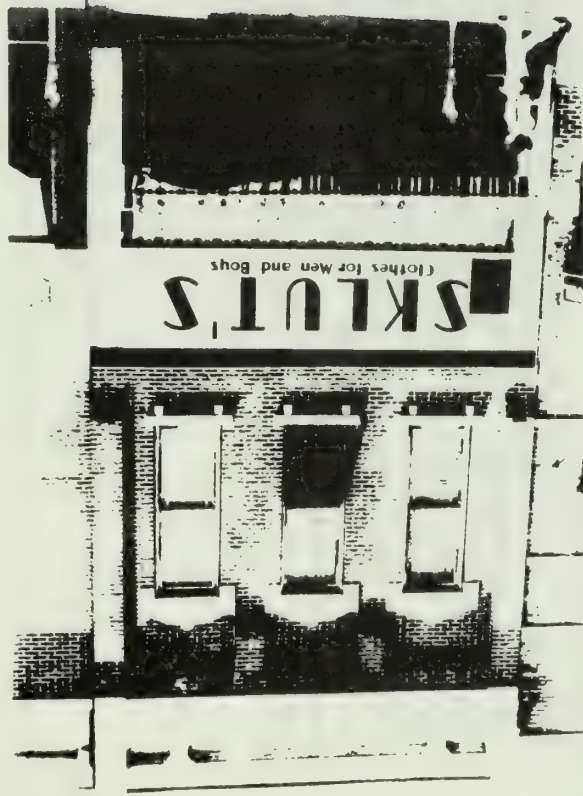
Roll 31, 35

Despite its modern facade treatment, the building is a compatible element in a block of 1890s brick commercial structure.

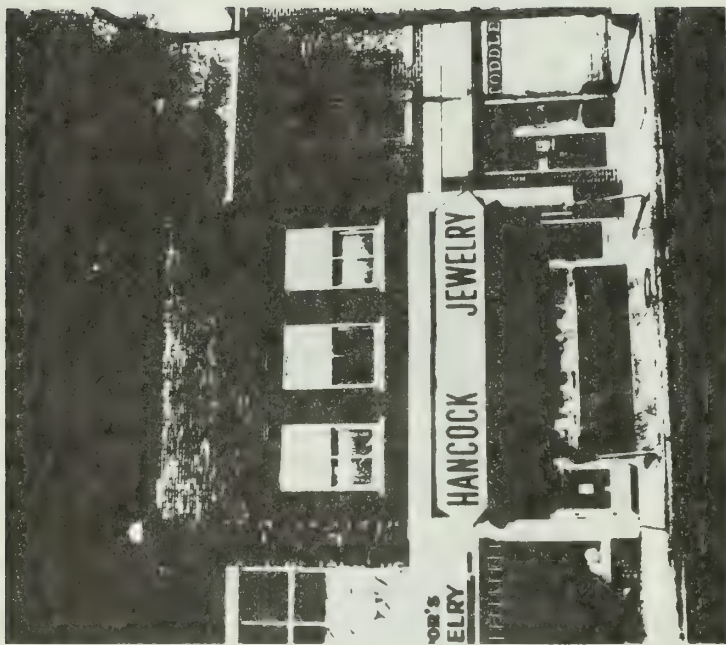
Roll 29, 13

Stone foundation; red brick, running bond on east, common bond on west. Rectangular plan; three-bay front. Two stories. Flat roof with parapet, stone coping on east. Storefront with off-center (south) entrance, glass display windows with black and tan opaque glass panels below; recessed entrance (north) to second story stair-case; second story has three one-over-one light double hung sash windows, stone lug sills. Main facade faces east; mid-block location on principal commercial street.  
Replaced wood frame bakery that was located on this site in mid-late 19th and early 20th century.

Element in central business district and element in 20th century continued development of Morris as commercial center for Grundy County. Compatible in scale, style and materials with surrounding commercial structures.

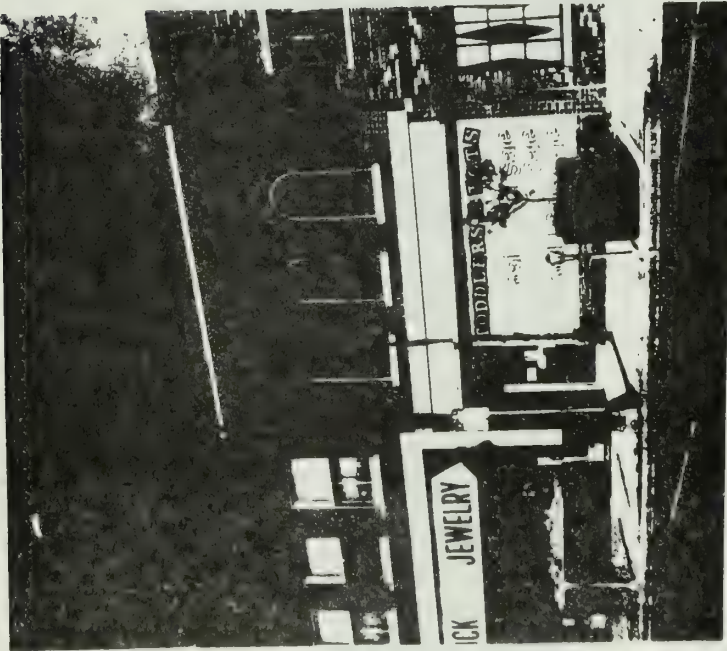
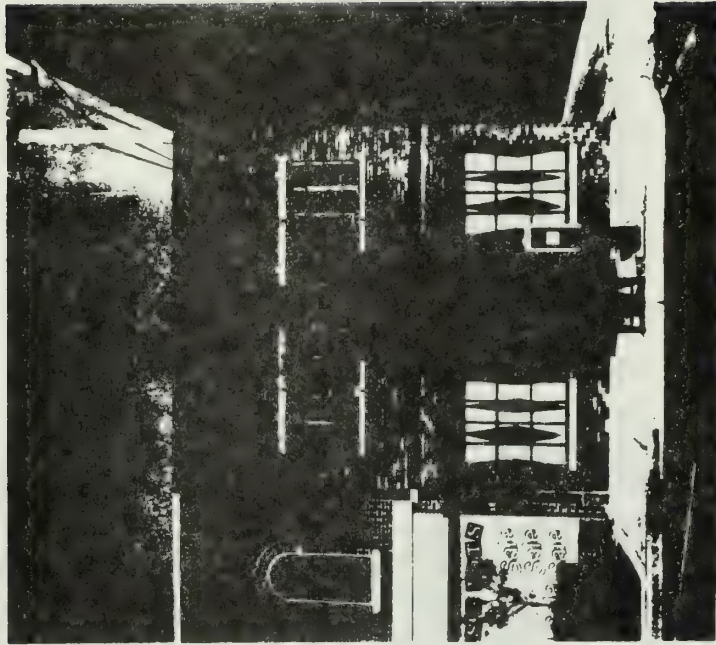
Roll 29, 14

Red rug running bond brick on south end of main facade and tan modified Flemish bond brick on north end of main facade. Rectangular plan; seven-bay two-storefront main facade. Two stories. Hipped roof with composition shingles and roll roofing; parapet wall on east with stone and concrete coping; stepped parapet with terracotta coping on north. Two modern replacement storefronts on main facade, south end with off-center entrance, north end center entrance. Second floor south end of main facade has three arched window openings with double row of row-lock lintels, stone sills; north end of main facade has four paired casement windows with transoms, flat limestone lintels and lug sills. Beltcourse of soldiers on main facade; southend of main facade has corbeled brick cornice. Main facade faces east; mid-block location on principal commercial street, north side faces alley. May be early frame structure with brick structure built around it; two-story rear addition north half; one-story addition on south half; both facades are twentieth century replacements.

Possibly very eary Morris structure beneath later additions/changes. More research required to determine. 1856 map of Morris shows L-shaped building on site owned by Goold and Rainey.

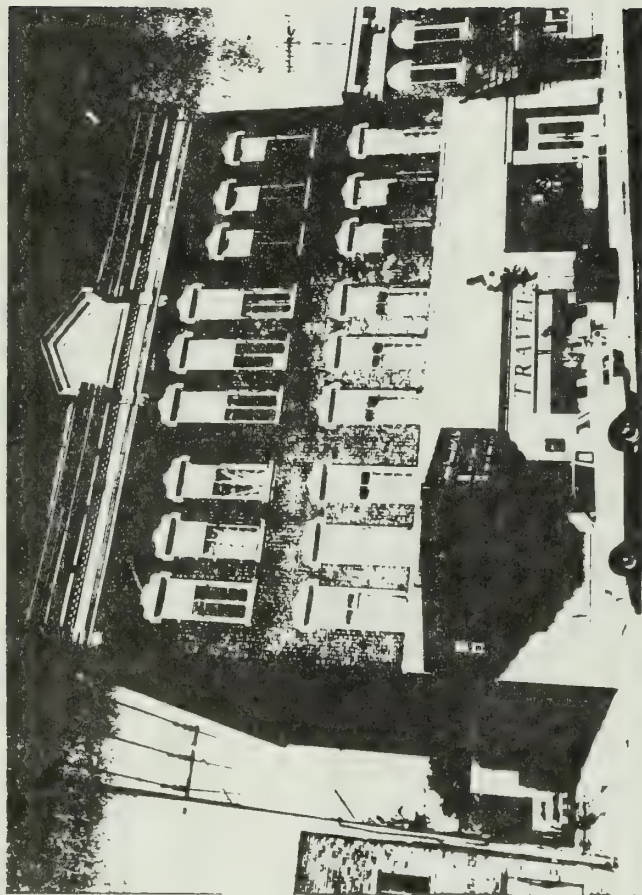
Roll 29, 7

Important building in the commercial history of Morris. One of the largest commercial blocks built in Morris during the rapid commercial development northward on Liberty Street in the 1870's-1880's. One of two commercial buildings built by Gebhard family, founder of the Gebhard brewery, an important Morris business from the 1860's until Prohibition. This structure is one of two Gebhard blocks built during the 1880's in this block of Liberty Street.

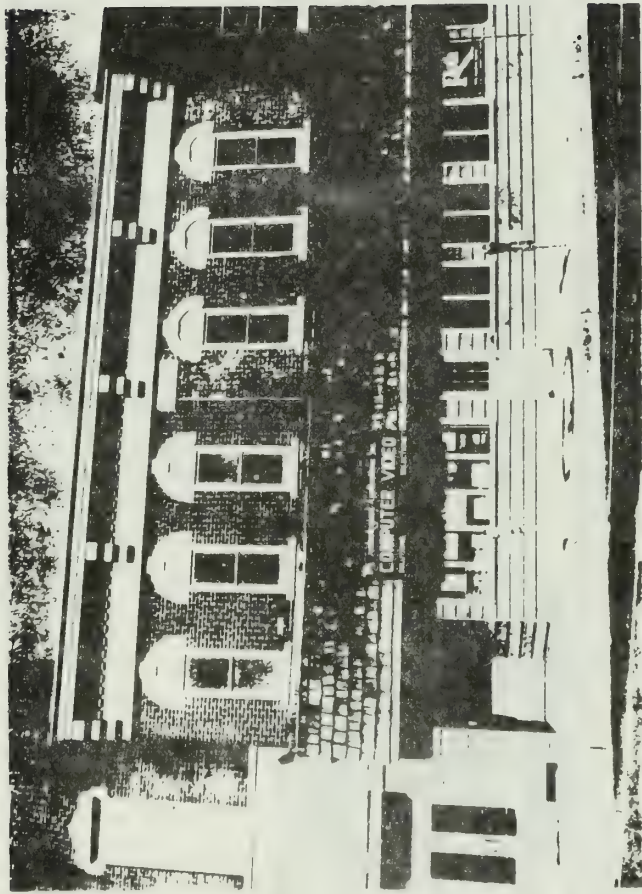
Roll 29, 17

Poured concrete foundation; common bond red brick bearing walls. Rectangular plan; six-bay two-storefront main facade. Two stories. Flat roof with parapet; metal covered cornice with bracket-like forms and dentil course. Modified storefront with horizontal wood siding, wood shingled pent roof, band of vertical single-light windows flanked by doors, south entrance recessed. Second story has six round-arched windows, two rows of rowlocks and rusticated stone keystones, one-over-one light replacement metal double hung sash windows with closed-off area in arch, lug sills. Name/date stone "Mrs. P. Smith 1881". Italianate commercial style. Main facade faces east; within block of principal commercial street. Added metal cornice covering.

Important element in the rapid commercial development of Morris in the last quarter of the 19th century. Although altered, second story still retains material and same detail of the original building appearance.

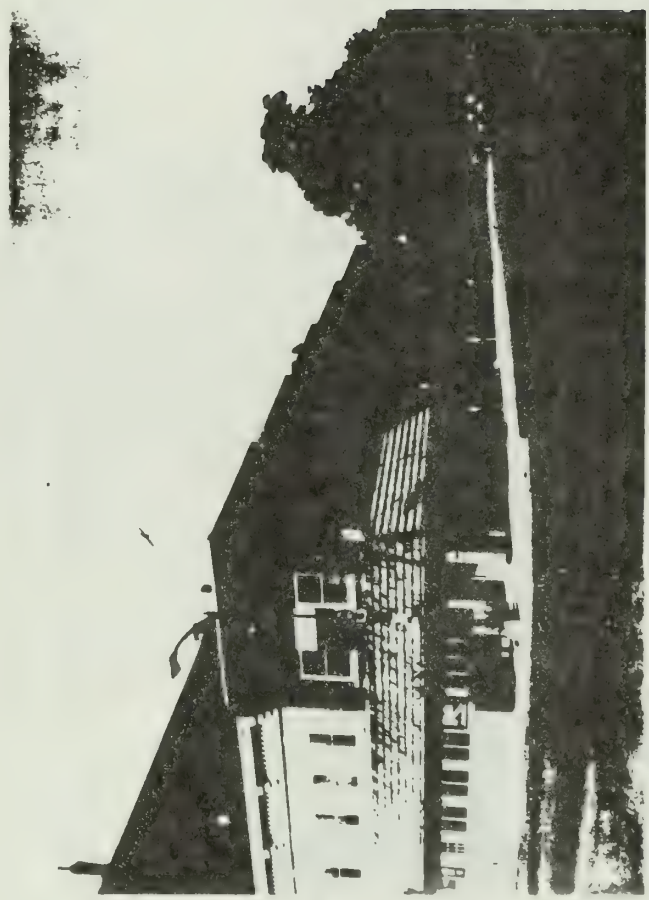
Roll 29, 18

Concrete foundation; running bond, rug brick walls. Rectangular plan; two-bay front. Two stories. Flat roof with parapet, stepped on north; stone coping on east, terracotta coping on north. Canted entrance on corner, modified storefront with horizontal wood siding and wood shingled pent roof carried over from 320 Liberty; second story has two one-over-one-light double hung wood sash windows, stone lug sills, brick lintels of soldiers. Secondary facade on Jefferson St. has added paneling with fixed windows on first story; second story has four one-over-one-light double hung sash alternating with four paired one-over-one-light double hung sash windows. Name/date stone "Roth 1916"; paneled brick cornice with row of rowlocks forming dentil course (above), rows of projecting and recessed stretchers to form frieze, and below a row of soldiers forming architrave. Main facade faces east; corner location on principal commercial street. Building replaced earlier wood-frame structure.

Important corner location on principal commercial street. Twentieth century commercial structures that blends in style, scale, and materials with earlier commercial structures in Morris.

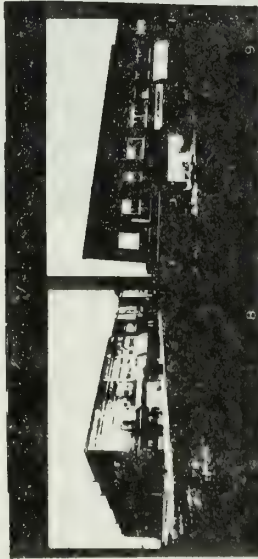
Roll 37

Corner location on principal commercial street that developed northward from Canal beginning in 1870's. Earlier buildings reclad in early part of twentieth century; resemble later structures in block rather than 19th century commercial buildings.

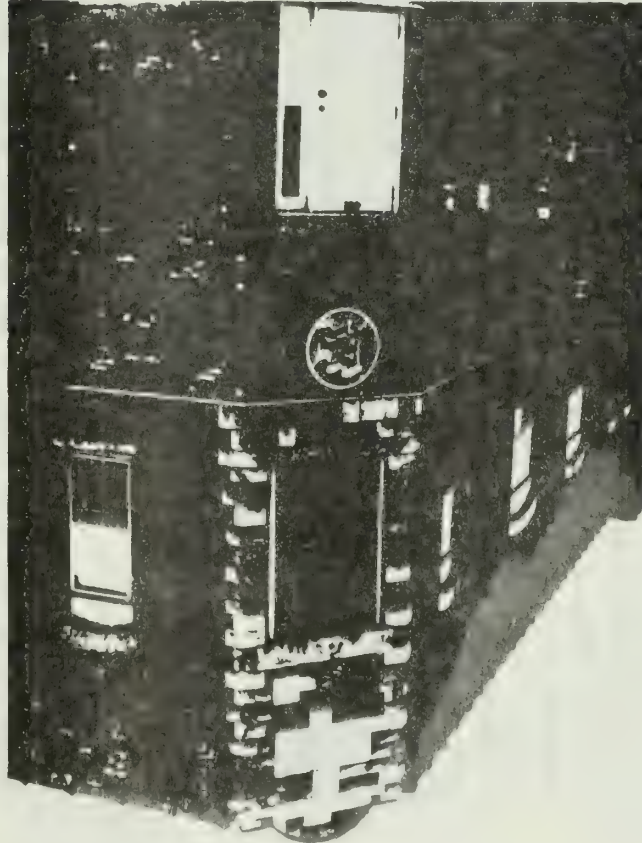
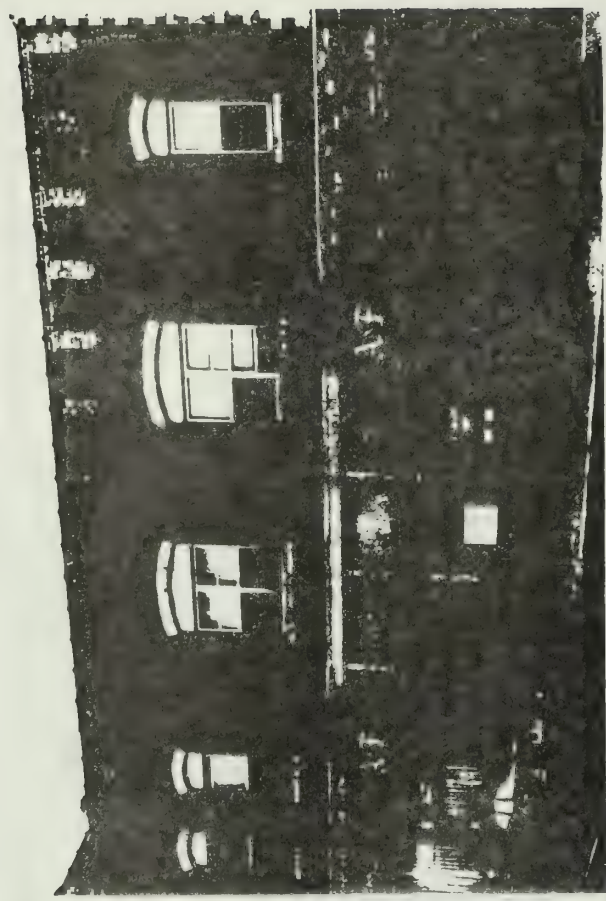
Roll 30, 17

Occupying a prominent corner site in the central business district, this commercial block illustrates the northerly progression of commercial activity along Liberty St. from the I&M Canal to the railroad in the early 1900s.

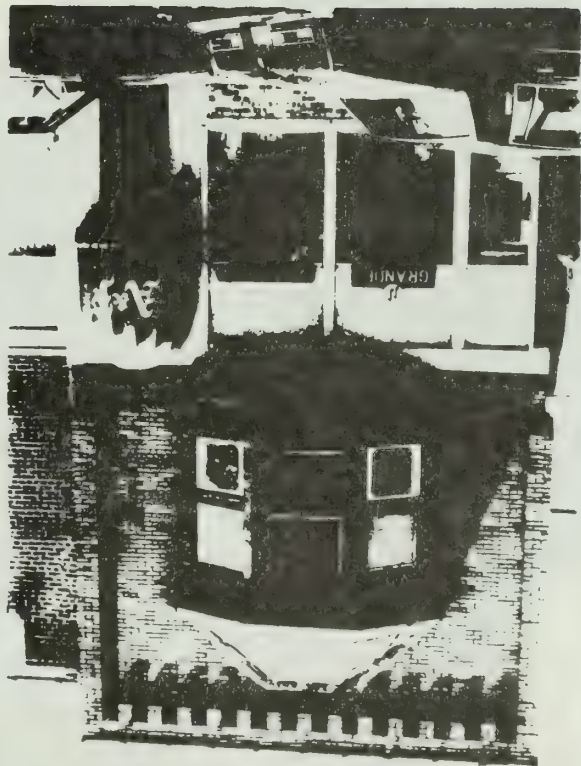
Roll 31, 28

Compatible in size and appearance with its surroundings, the structure illustrates the scale and variety of commercial activity generated by the I&M Canal and the railroad during the 1800s. Subsequent alterations have compromised the architectural integrity of the structure.

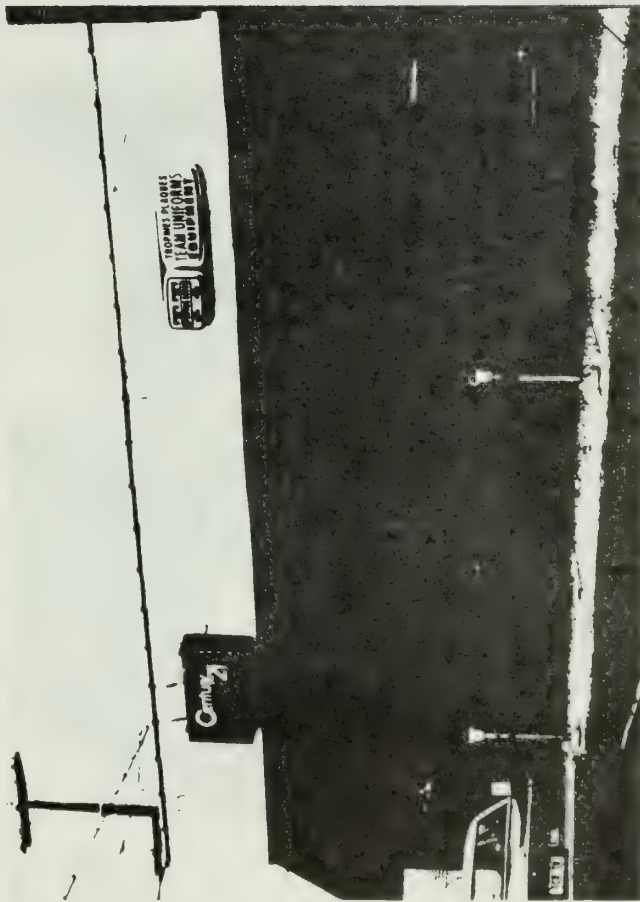
Roll 30, 19

Despite its modern facade treatment, the building illustrates the scale and variety of commercial activity generated by the I&M Canal and the railroad in the 1800s. Subsequent alterations and additions have compromised the architectural integrity of the structure.

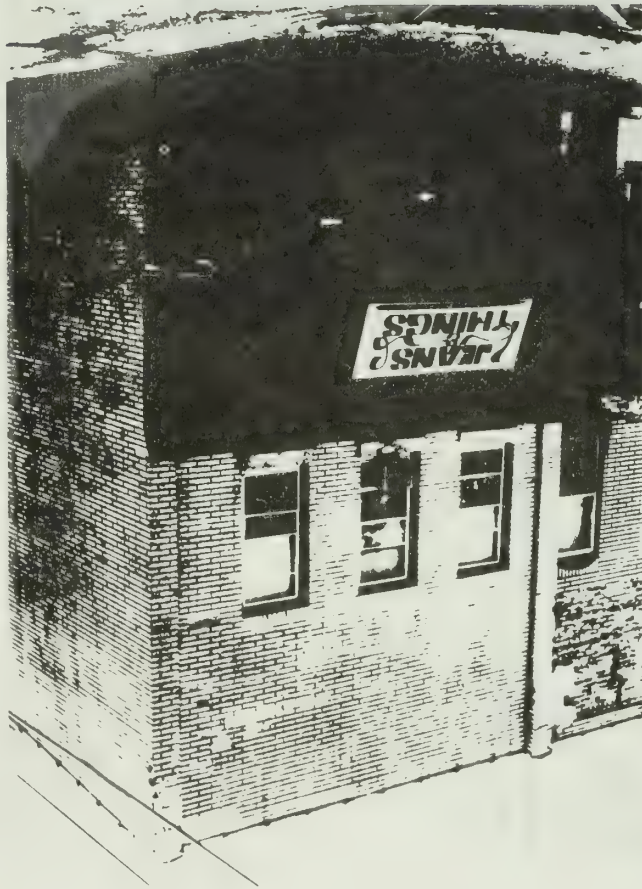
Roll 30, 20

The building illustrates the scale and variety of commercial activity generated by the the I&M Canal and the railroad in Morris in the late 1800s. Building is a compatible element in a block of two-story 1880-1890 commercial structures. Subsequent alterations and additions have compromised the architectural integrity of the structure.

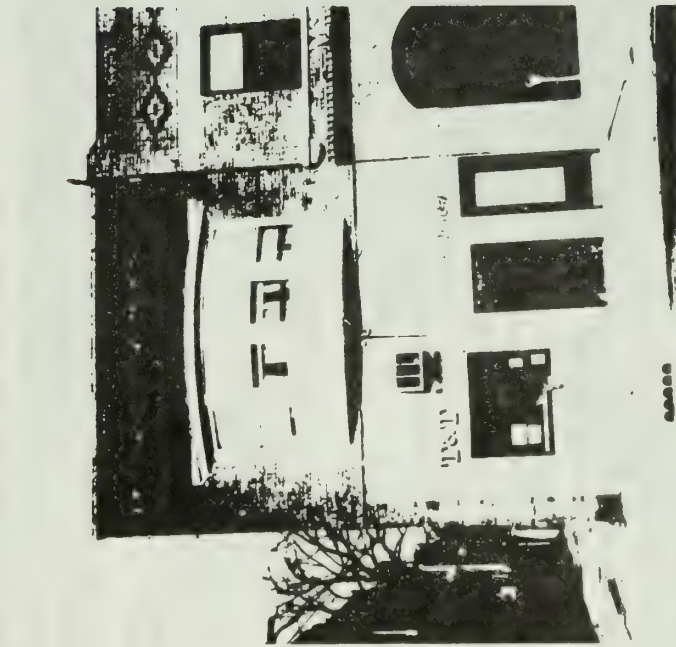
Roll 37, 13

Poured concrete foundation, common bond red brick walls on south, main facade has running bond tan brick. Rectangular plan; three-bay one-storefront facade. Two stories. Flat roof, parapet with concrete coping on east, stepped parapet with terracotta coping on south. Modern storefront with vertical wood siding, two glass wood-frame doors and fixed plate glass window. Second story has two elliptical oriels (one on main facade and one on south) with four one-over-one-light metal frame double hung sash windows, flat roof with dentil course under eaves. Cornice frieze of two rows of projecting rowlocks with row of brick soldiers below. Main facade faces east; located in block on principal commercial street.

Element in central business district; example of twentieth century continued importance of Morris as commercial center for Grundy County and continued northward development of Liberty St as principal commercial street.

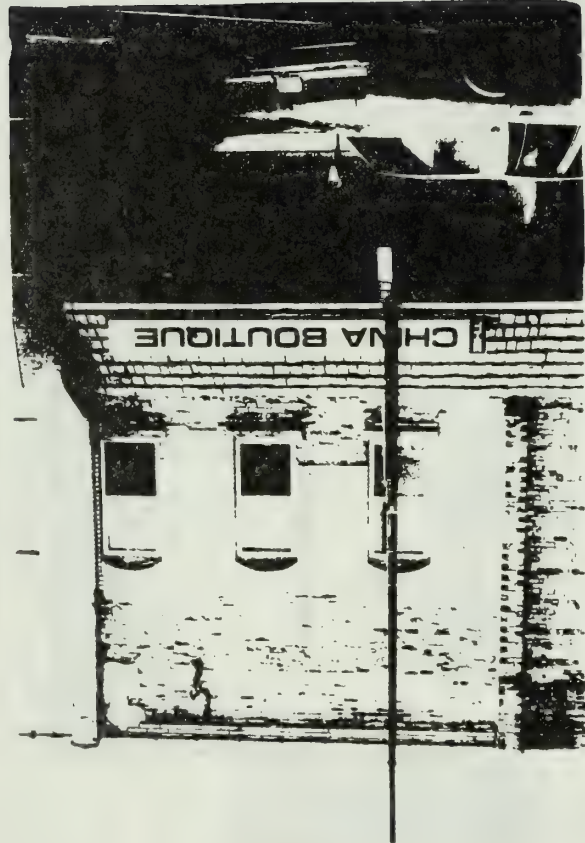
Roll 31, 27

The building illustrates the scale and variety of commercial activity generated by the I&M Canal and the railroad in the late 1800s. Despite its smaller scale, this building is a visually compatible element in a block of two-story 1890s commercial structures. Subsequent alterations and additions have compromised the architectural integrity of the structure.

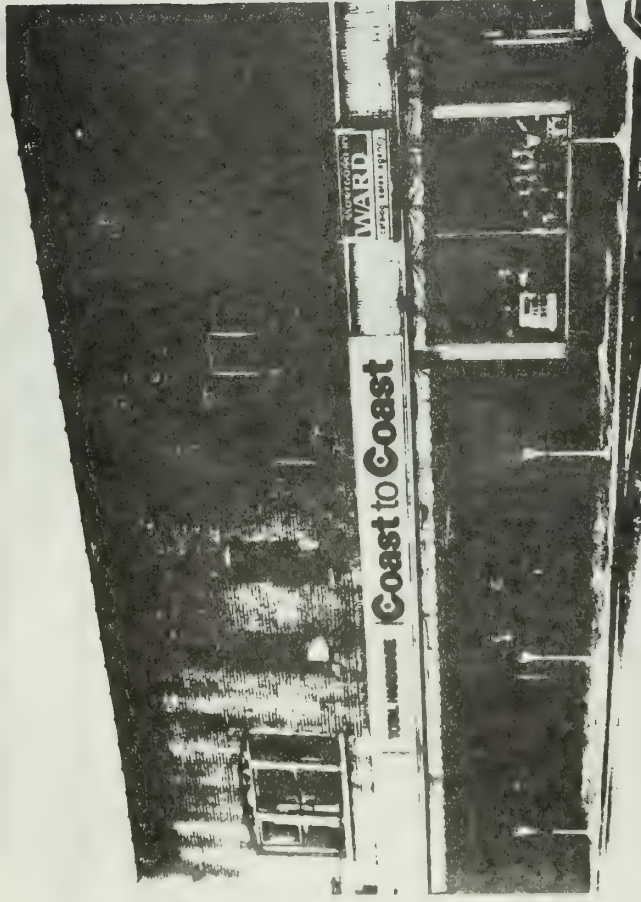
Roll 30, 23

Occupying a prominent corner lot in the central business district of Morris, this building illustrates the northerly progression of commercial activity along Liberty St. from the canal to the railroad in the early 1900s. Subsequent alterations have compromised the architectural integrity of the structure.

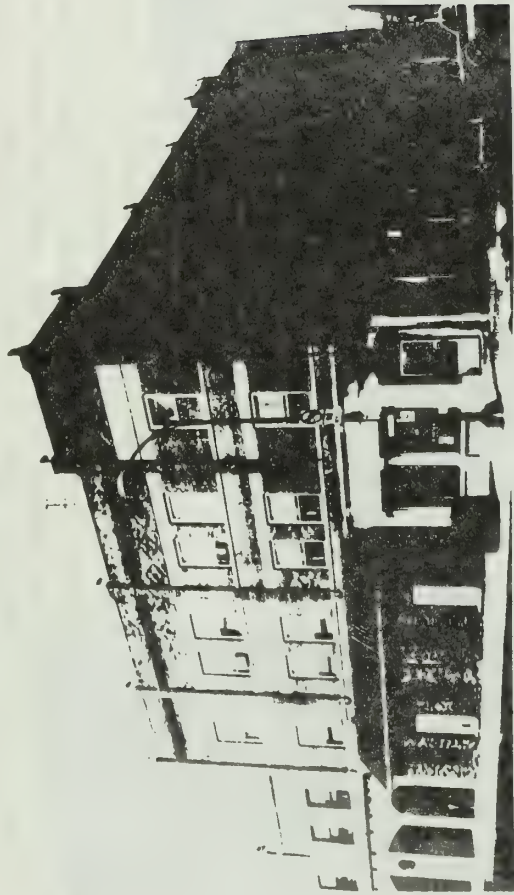
Roll 37, 15

**LIBERTY** Major early 20th century commercial block, built at northern edge of core area of central business district. Significant in the continued commercial development of Morris as the commercial center for Grundy County and the development northward on Liberty Street that began in the 1870's. Various commercial activities were housed in the building including a bank on the northeast corner; the north monumental entrance, originally built to access apartments on the second and third floors, was also the entrance to the local hospital which was located on the upper floors of the building from 1906 until 1909-10 when the current hospital building was completed; The Collins family has been important in Morris history as prosperous farmers.

third story lintel on east face of northeast corner bays: "Collins 1905", on north "Collins" with floral design. Notable interior features include pressed metal ceilings and dado in entryway to 109 W. Jackson. Main facade faces east and north on southwest corner of Liberty and West Jackson Sts. The Collins family came to Grundy County from New York State in 1834; Jeremiah Collins and his two sons Joshua and Oscar were prosperous farmers. In addition to building this commercial block, Joshua and Oscar also constructed the Collins-McCabe house at 306 W. Main St.

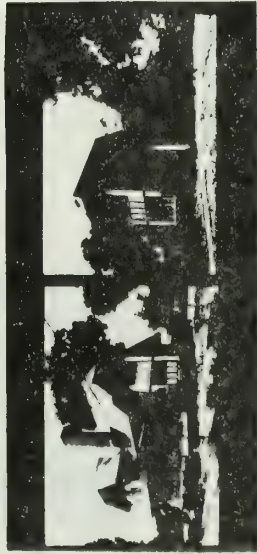
Roll 40

One of the finest early-20th century eclectic buildings in Morris. Exhibits elements of Tudor Revival, French Provincial, Arts and Crafts and Prairie styles. Built on foundation of earlier structure that burned in 1924. Located on west side of Nettle St. in area that retains examples of houses from difference periods of Morris' residential development from the 1850s-1920s.

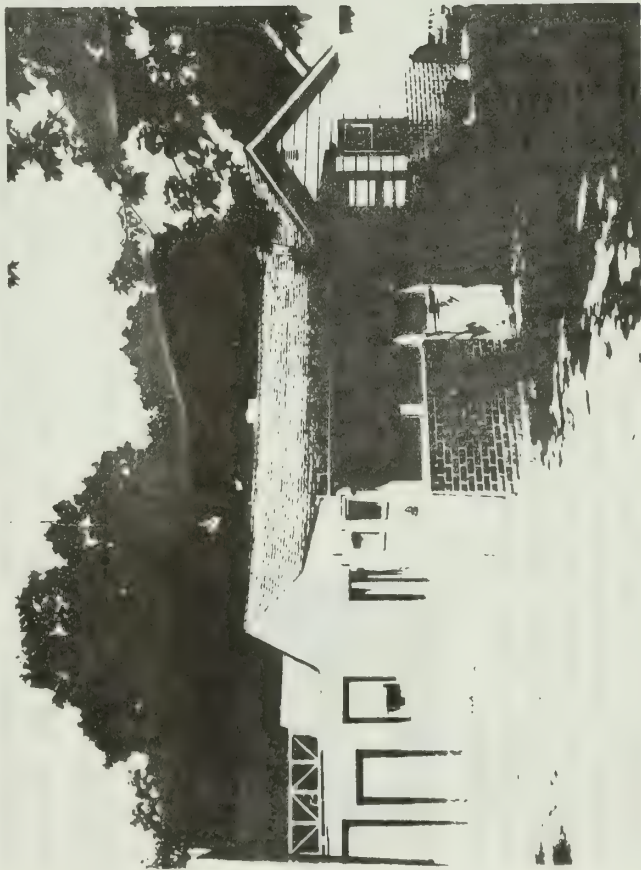
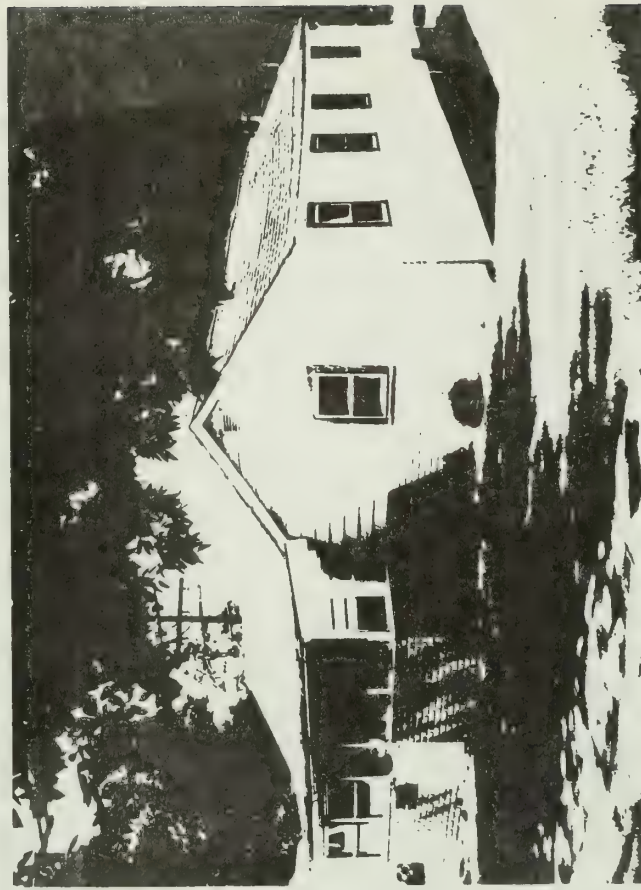
Roll 44, 30

418 and 420 Nettle St. are similar vernacular one-story cottages that have been greatly altered and retain little visual integrity. Buildings may have been associated with the gas works which were located in the same block on the corner of Nettle and W. Jefferson Sts.

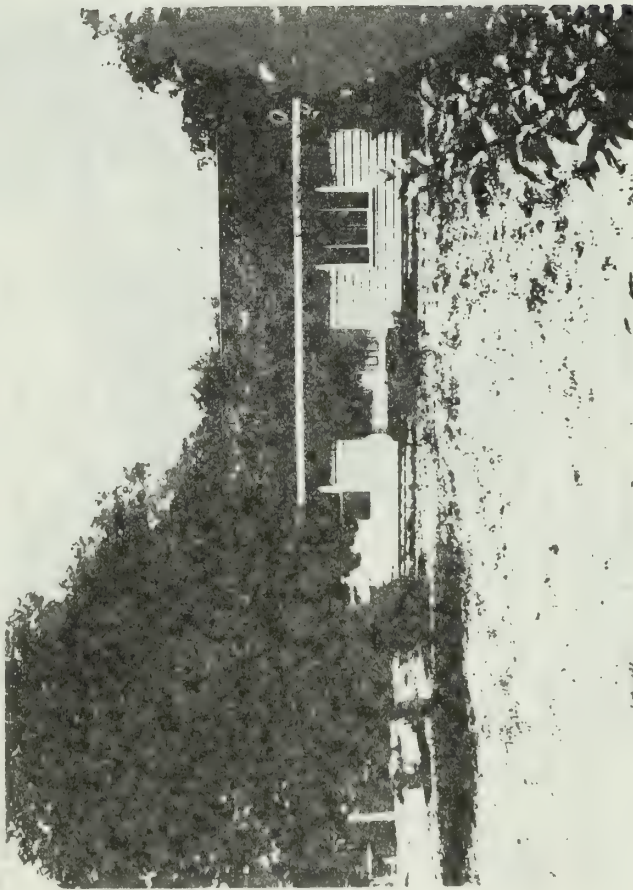
Roll 44, 20

Concrete block foundation; wood frame construction; textured vinyl cladding. L-shaped plan with four-bay front. One story. Side-gable roof, extended gable on northwest corner, asphalt shingles. One interior chimney on west face of roof. Recessed entrance with replacement paneled door; two one-over-one-light double-hung sash windows and paired sliding glass windows on front; one-over-one-light double-hung sash windows on sides. Main facade faces east; main ridge runs north-south; gabled weatherboarded outbuilding. Completely re-sided to resemble modern ranch-style house.

Alterations have completely obliterated historic integrity of structure.

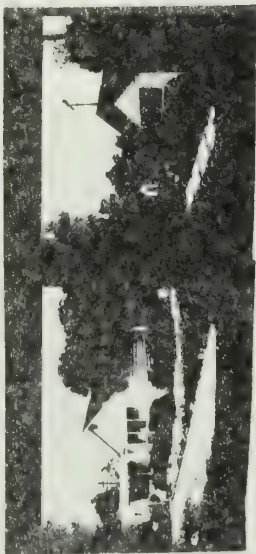
Roll 40

Limestone foundation; wood frame construction; aluminum siding. Irregular plan, with extended rear wing, enclosed entry porch. One story. Intersecting gable roof with asphalt shingles. One interior chimney on south face of northern east-west ridge. Enclosed entry porch with metal storm/screen door and band of casement windows; six-light picture window with heavy mullions on front facade gable end; awning windows on sides. Main facade faces east; similar to 418 Nettie St. One-story hip roofed detached two-car garage. Numerous alterations and additions.

418 and 420 Nettle St. are similar vernacular one-story cottages that have been greatly altered and retain little visual integrity. Buildings may have been associated with the gas works which were located in the same block on the corner of Nettle and W. Jefferson Sts.

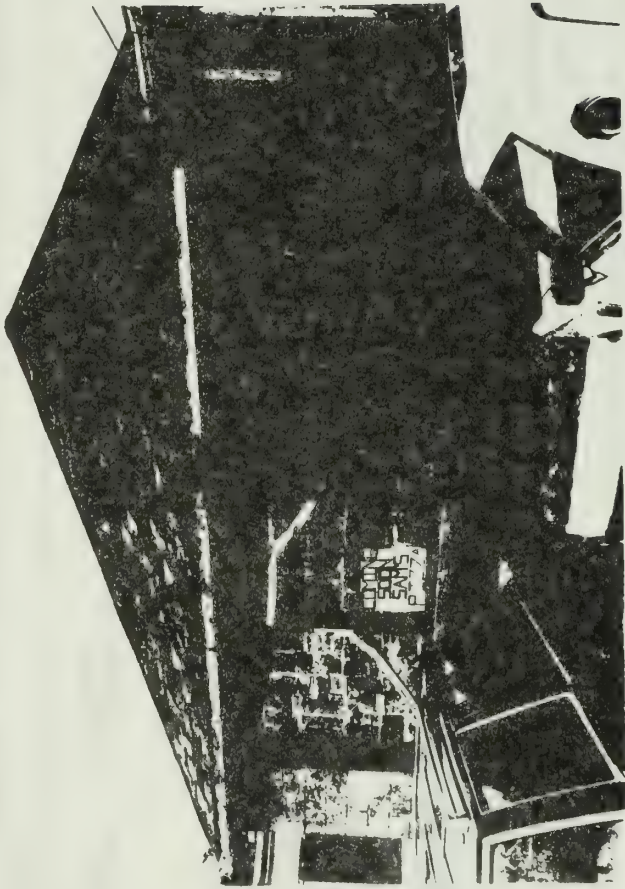
Roll 28, 26

Building is of a smaller scale than much of the industrial and commercial development that occurred along the I&M Canal.
